MEMORANDUM

SUBJECT: Site Assessment: Certain-Teed-Maline Creek Site,
Bellefontaine Neighbors, St. Louis County, Missouri
TDD#: T07-9209-003
PAN#: EM00307SBA
EPA/OSC: Don Hamera

Photographic Record

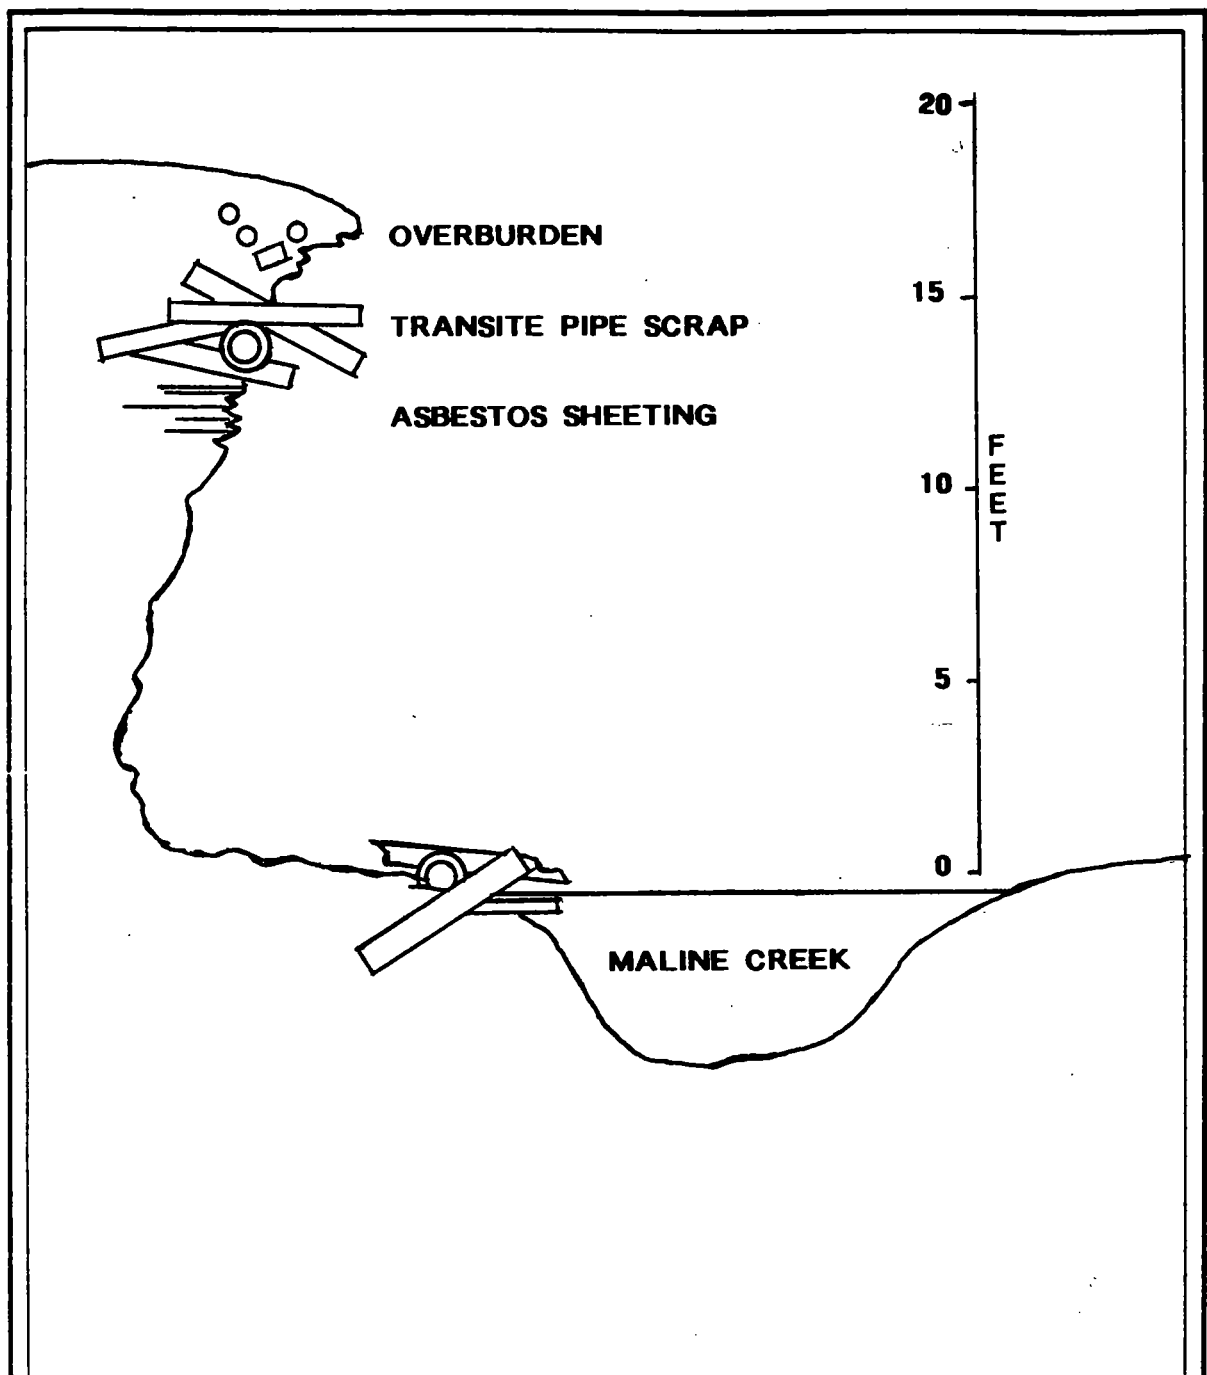
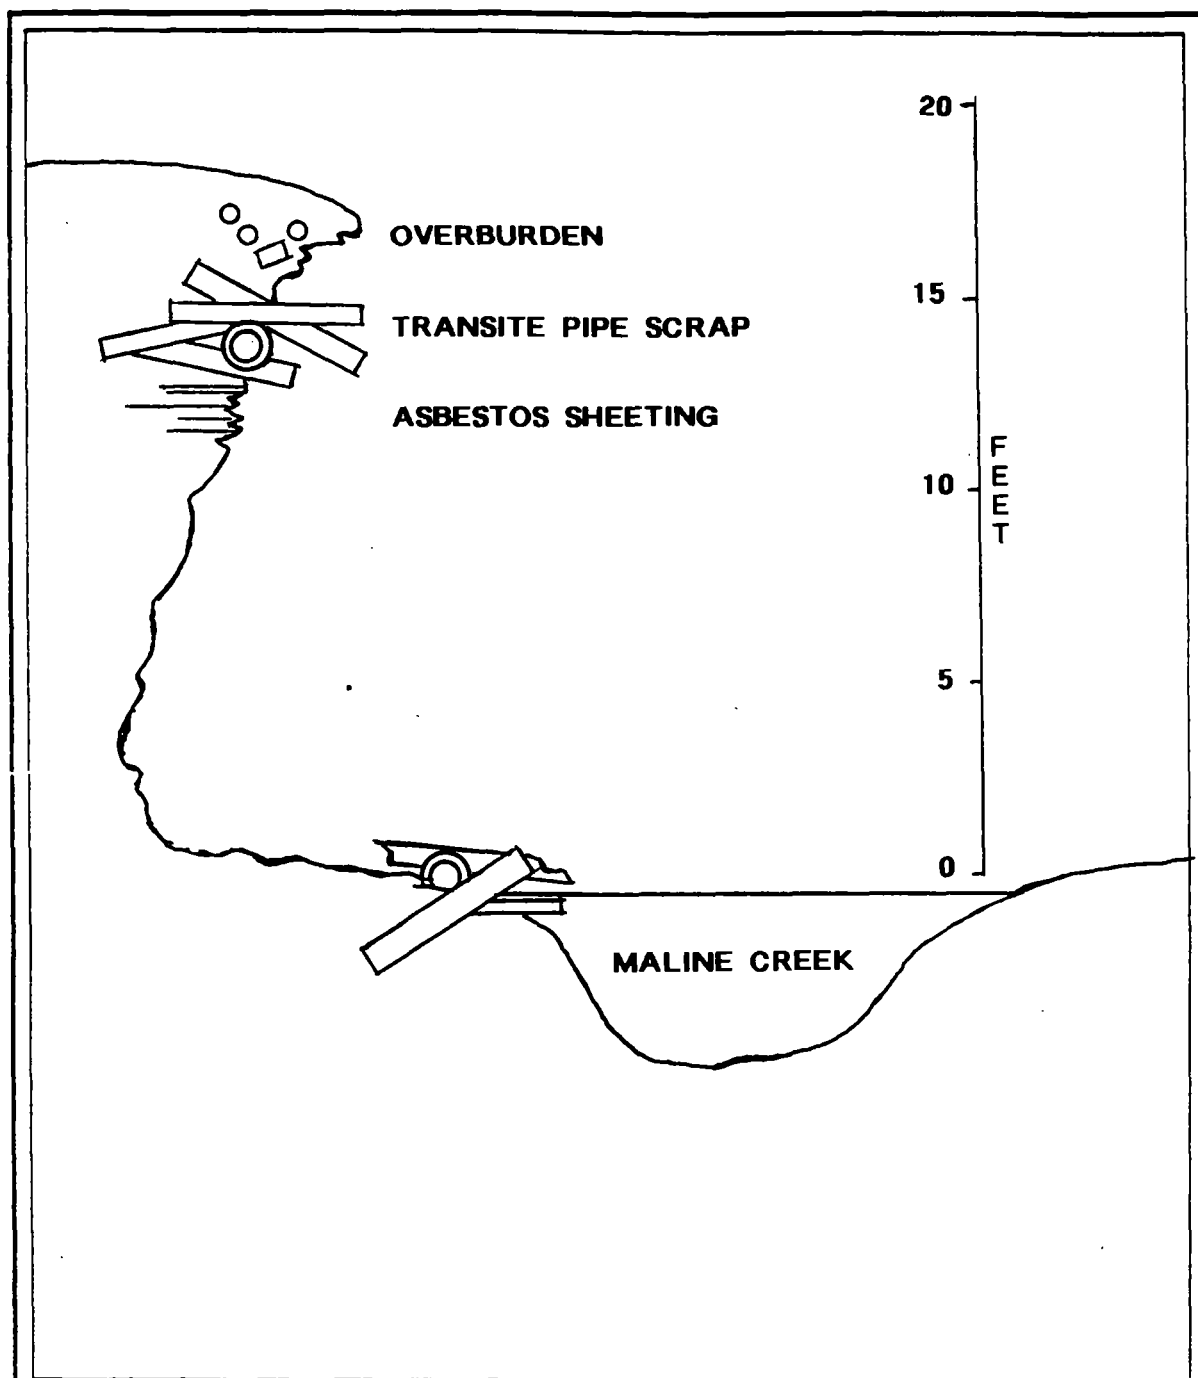
**FIG. 1 CROSS SECTION OF LANDFILL
EXPOSED AT MALINE CREEK**

- * The transit pipe is exposed at a cut bank of the Maline Creek where the creek bends from a northwest-southeast direction to a nearly east-west direction (refer to Site Map).
- * The bank where the pipe is exposed is approximately 15 to 20 feet high and from 150 to 200 feet in length (refer to Site Map and Fig. 1).
- * The landfill, where exposed, consists of three distinct layers (refer to Fig. 1 and Photolog). The first layer, approximately two feet thick, is comprised of a soil cover mixed with pipe fragments and connector rings. The second layer, approximately two to three feet thick, is comprised almost exclusively of transit pipe fragments and connector rings with no apparent fill material. The third layer, approximately two feet thick, is comprised of asbestos sheeting, some insulation material, and fill.

- * The top two layers overhang the bank approximately two to three feet. There are areas where cave-ins and slumping have occurred, leaving transit pipe and debris near the edge of the creek or in the creek itself (refer to Fig. 1 and Photolog).

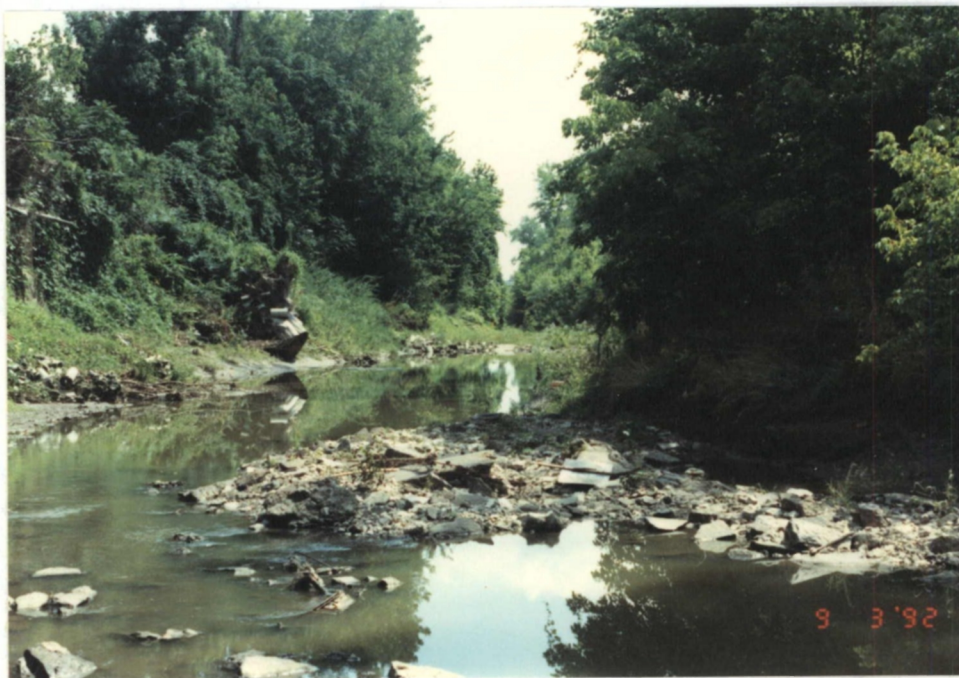
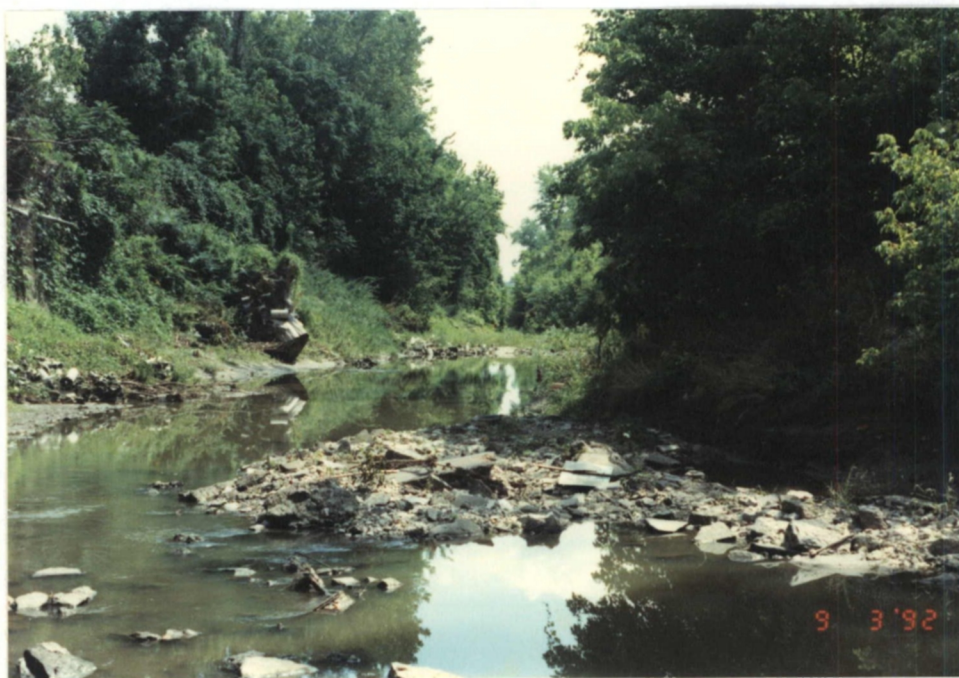
Site overview, looking
downstream

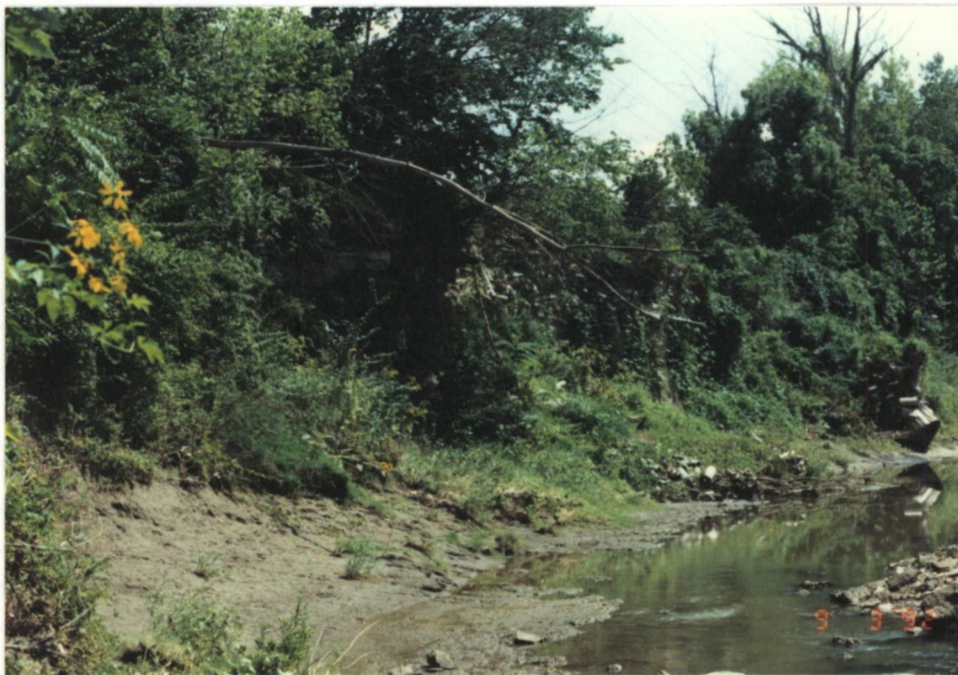
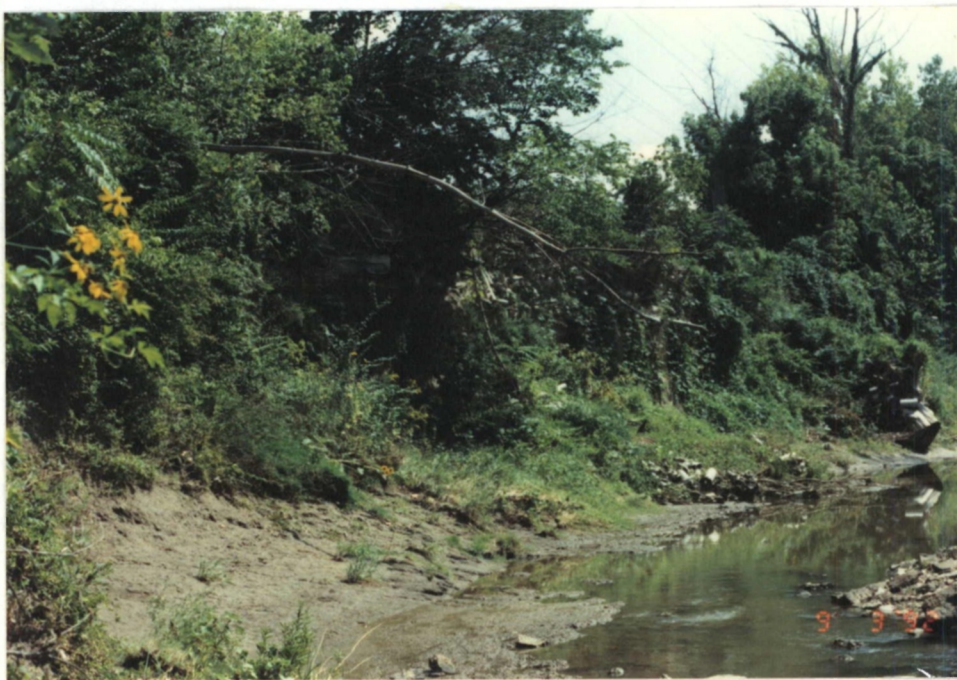
Overview of bank, downstream

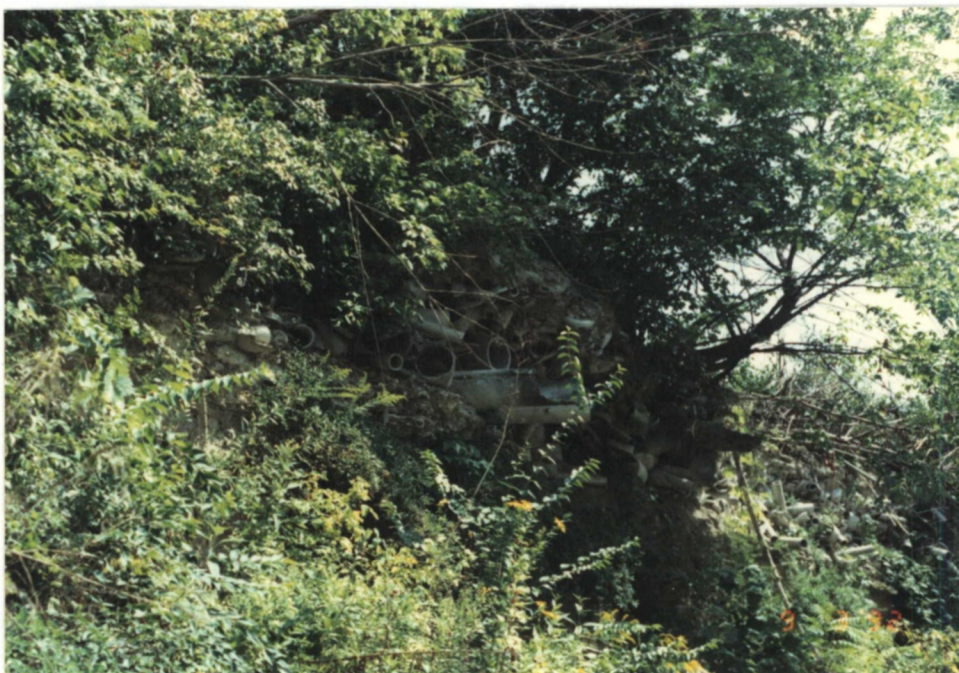
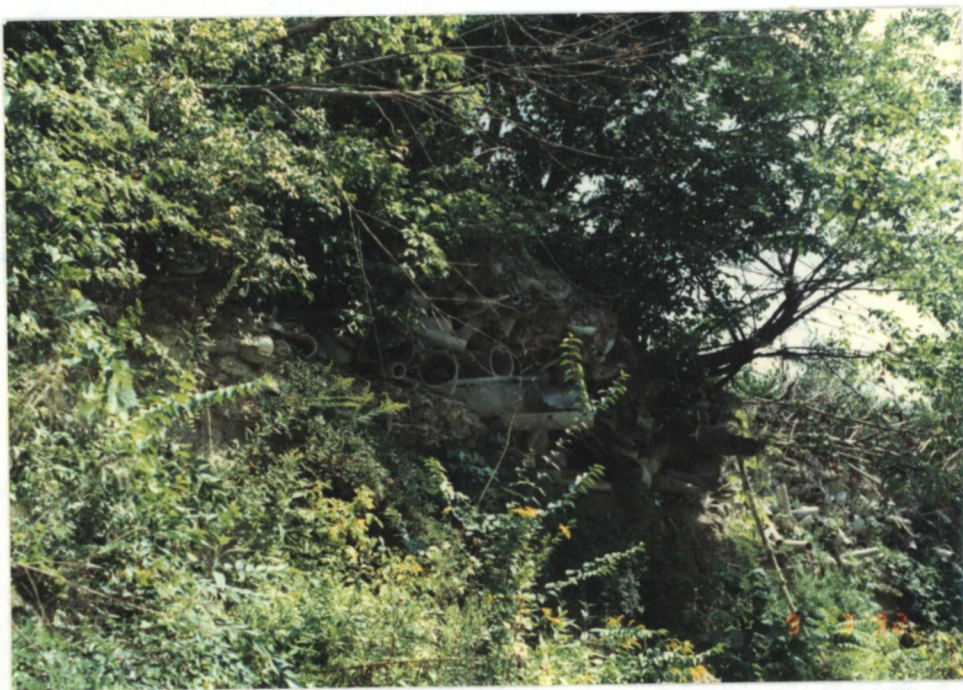
Bank, NE side of creek

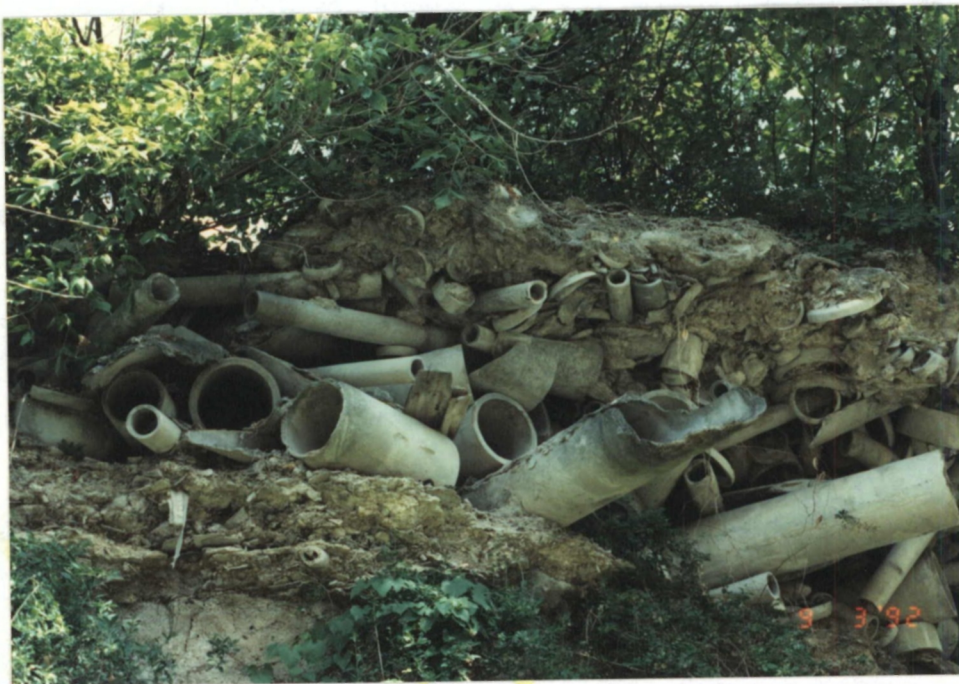
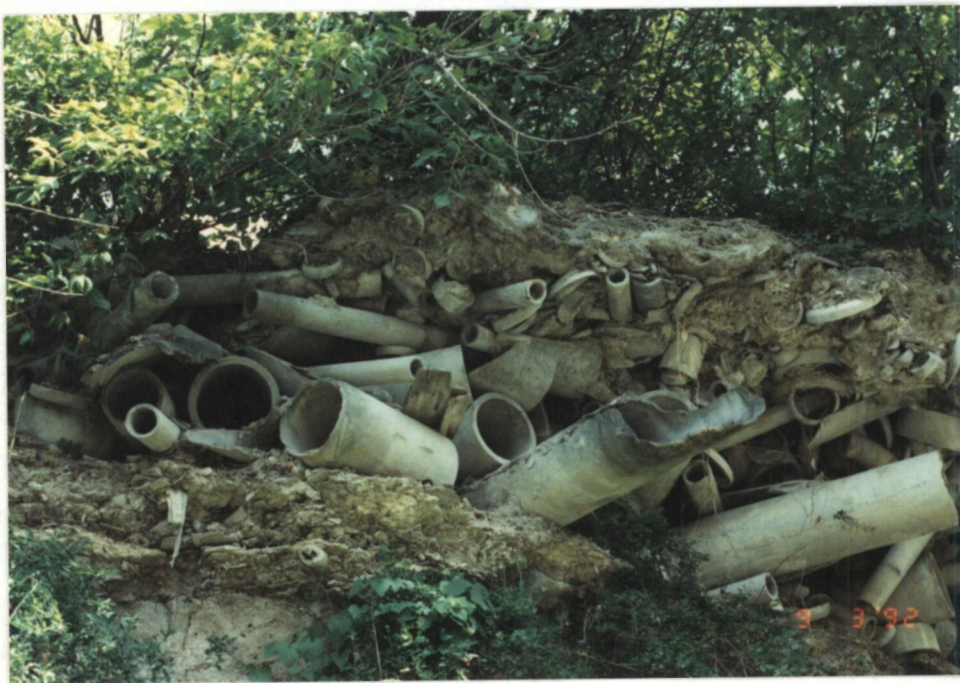
Top six feet of bank

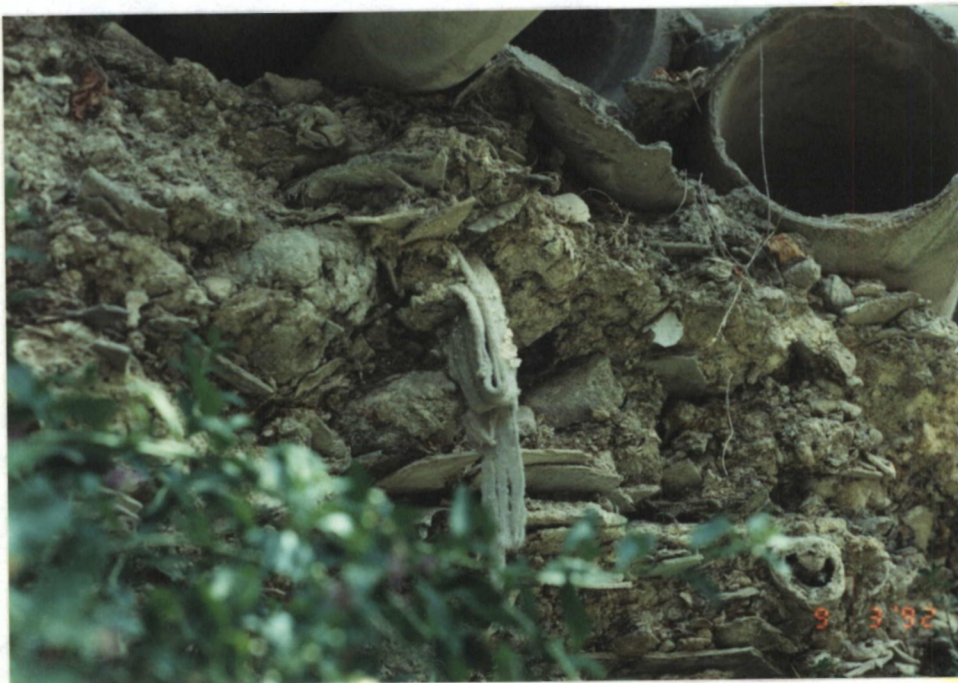
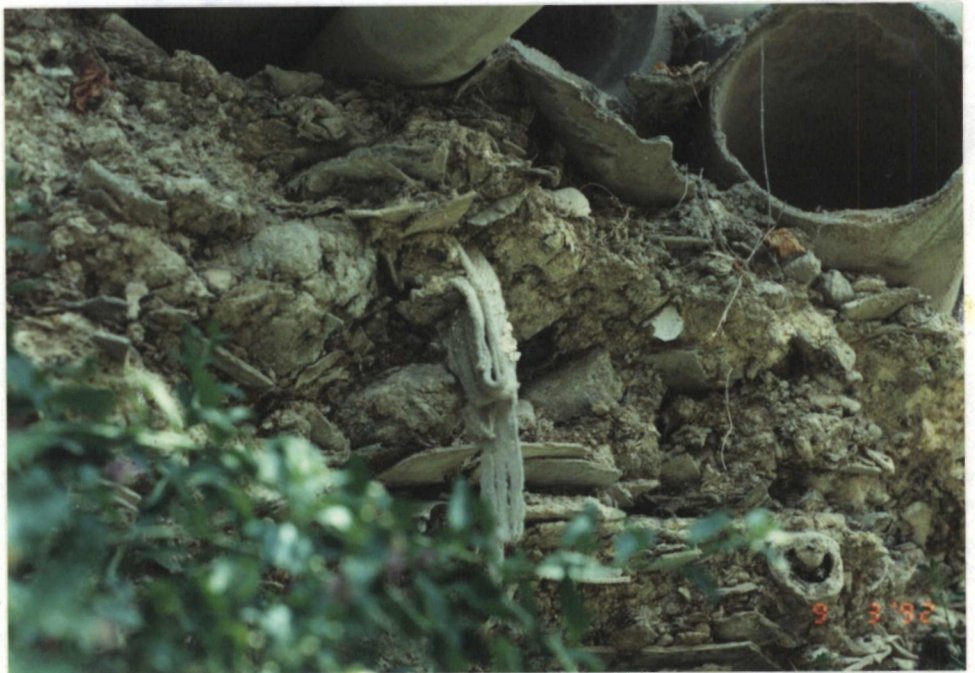
Close view of bank showing
'insulation' material

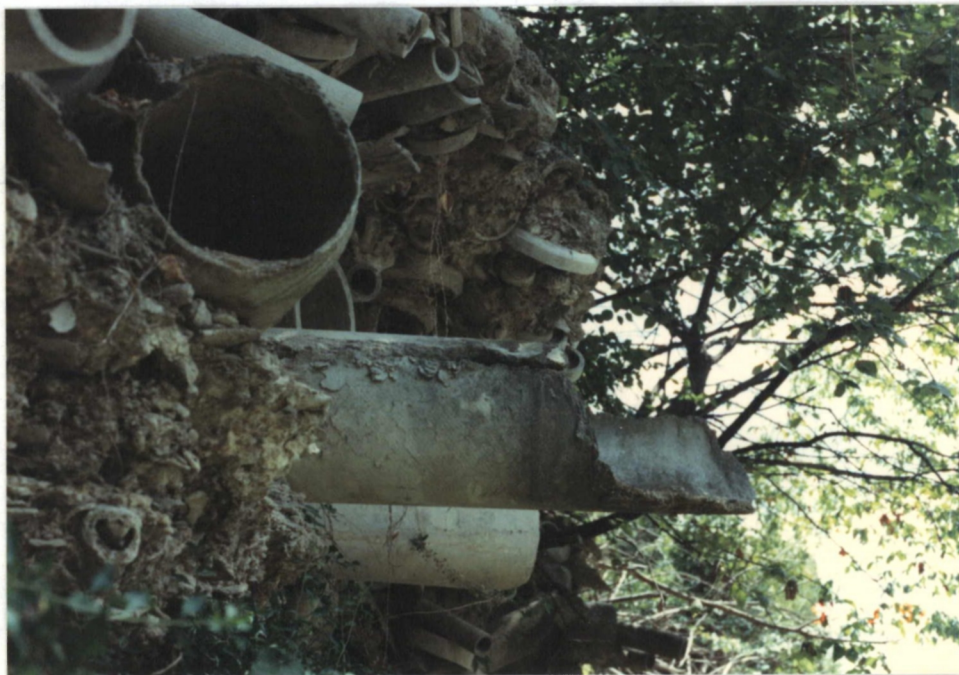
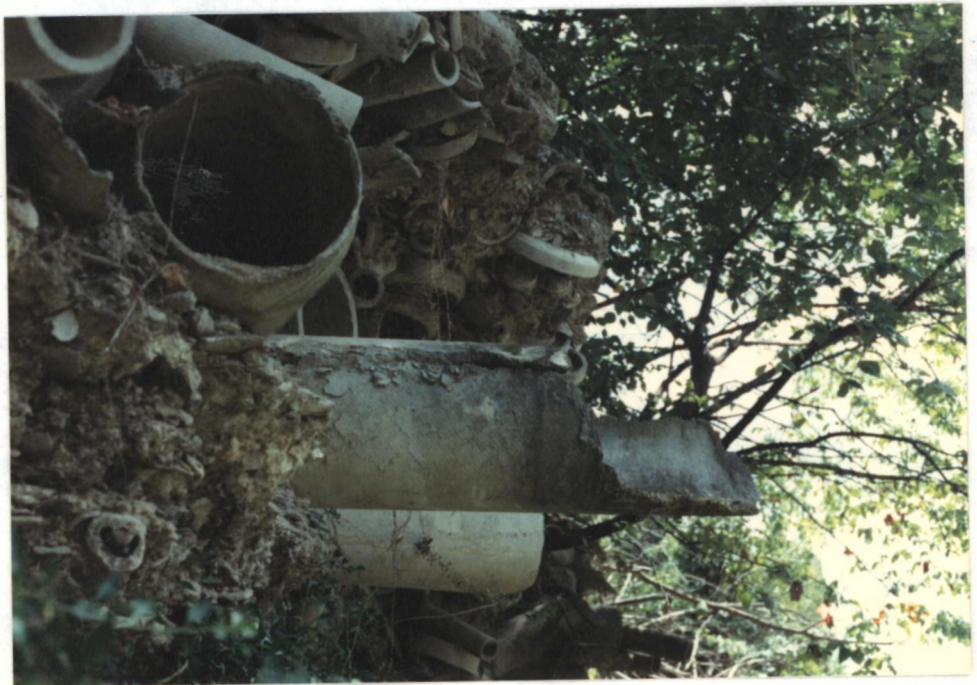
Transite pipe protruding from
bank

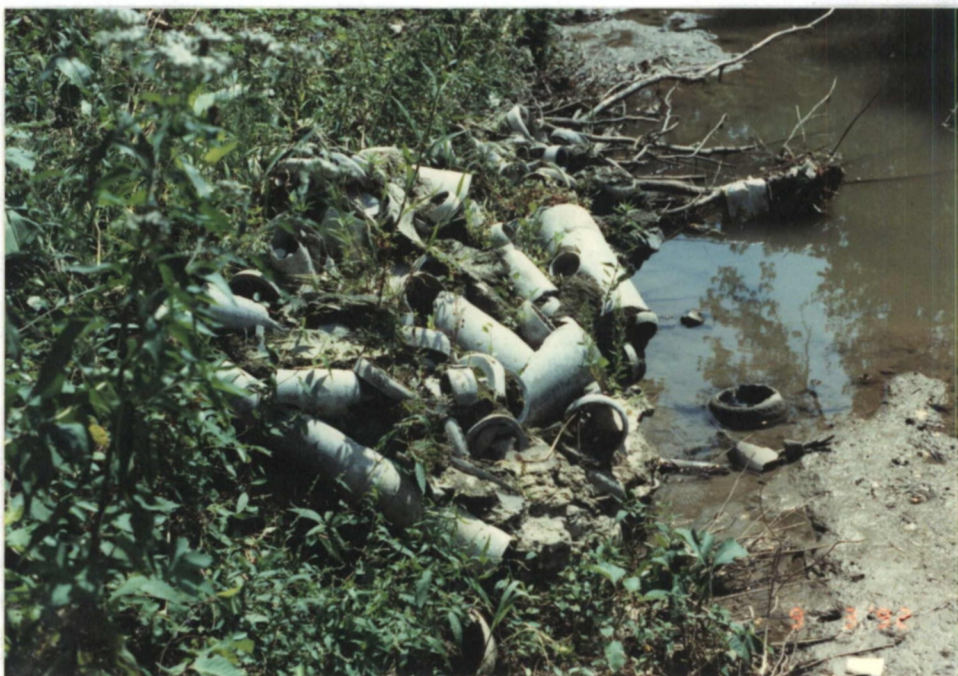
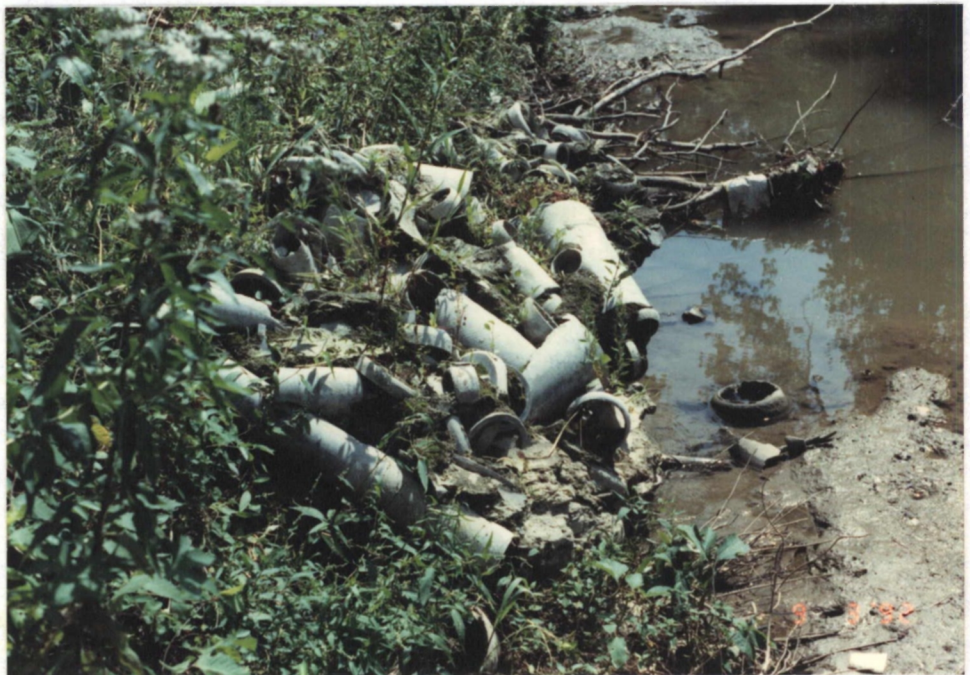
Transite pile near creek

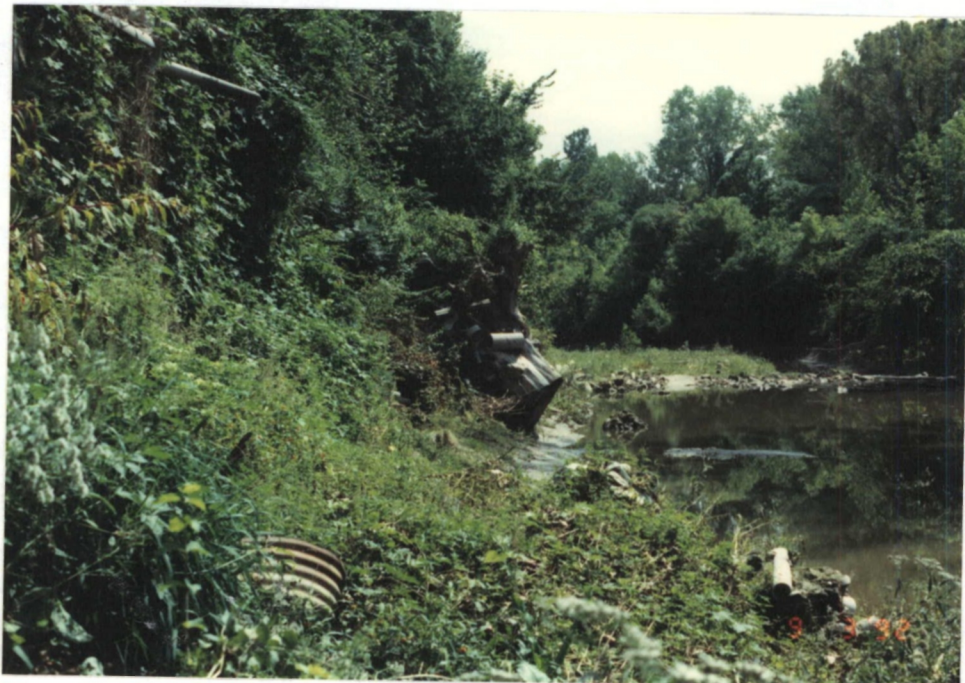
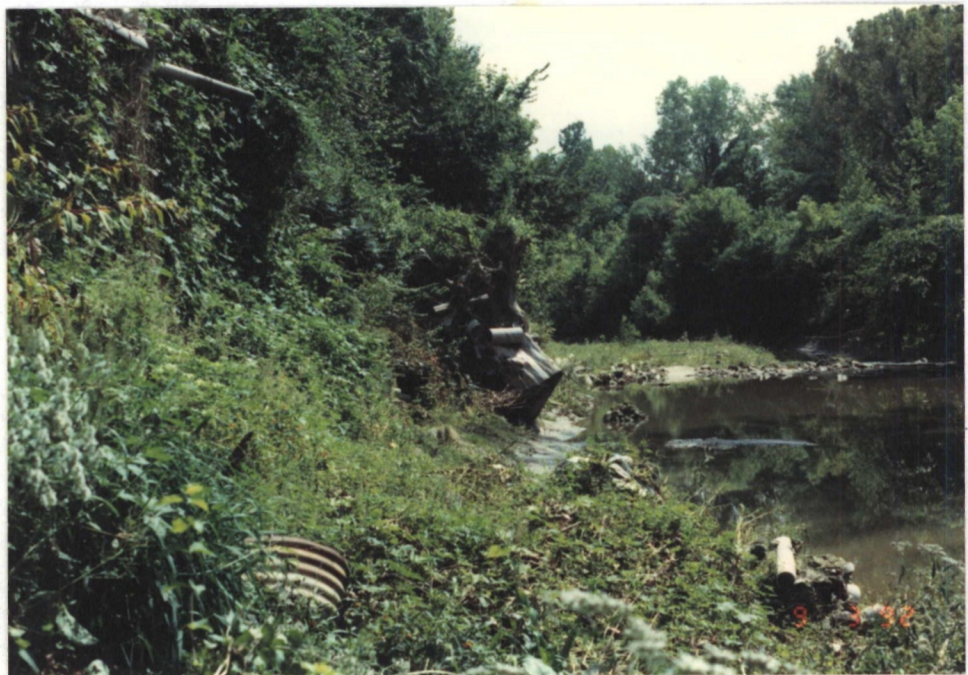
Transite pipe/fallen stump

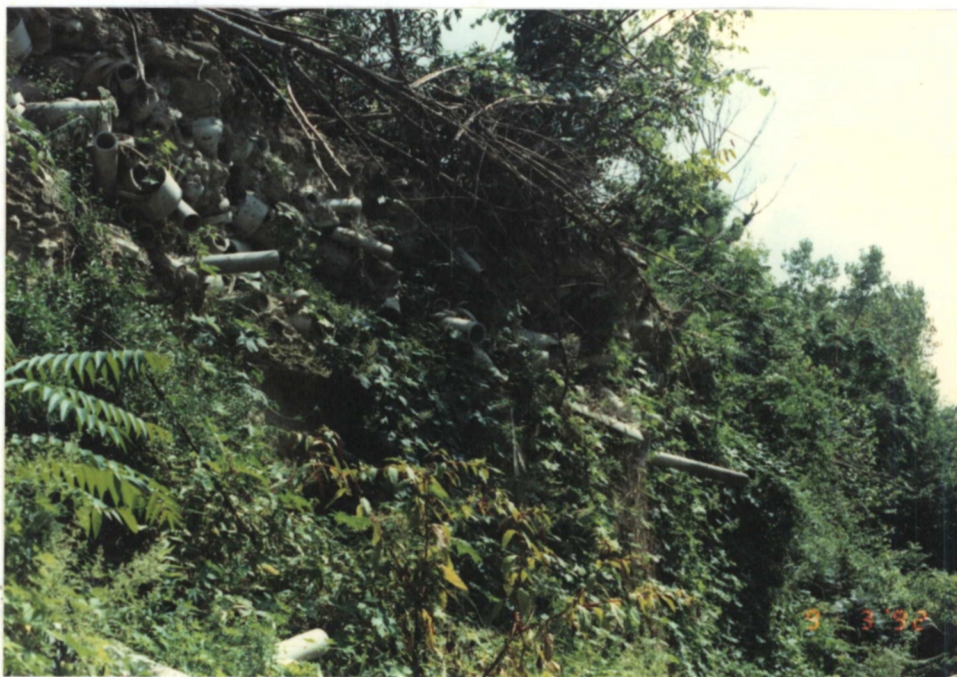
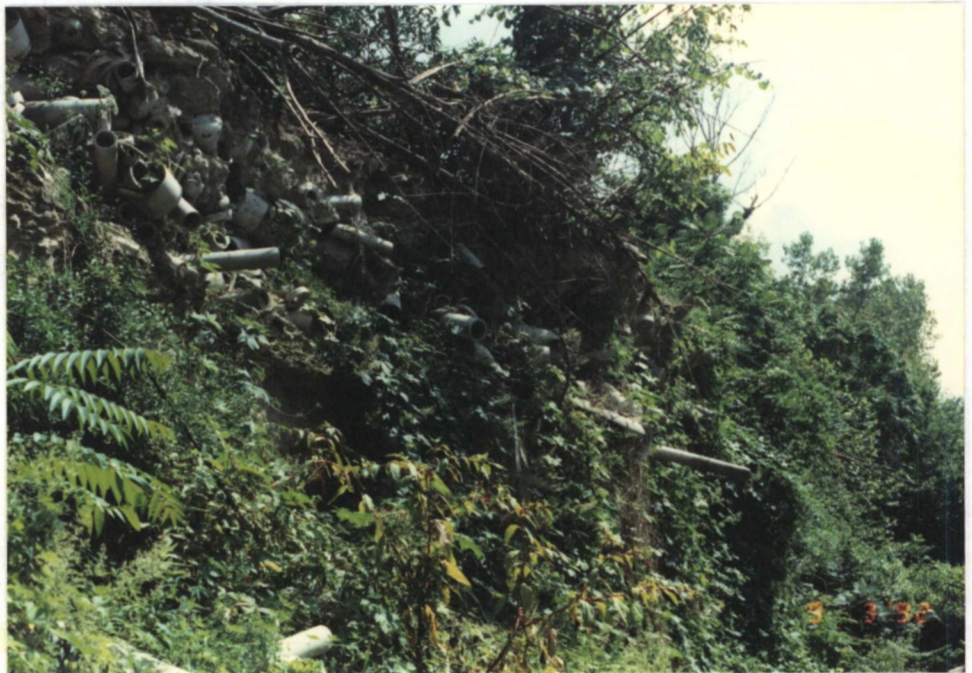
SE extremity of bank erosion

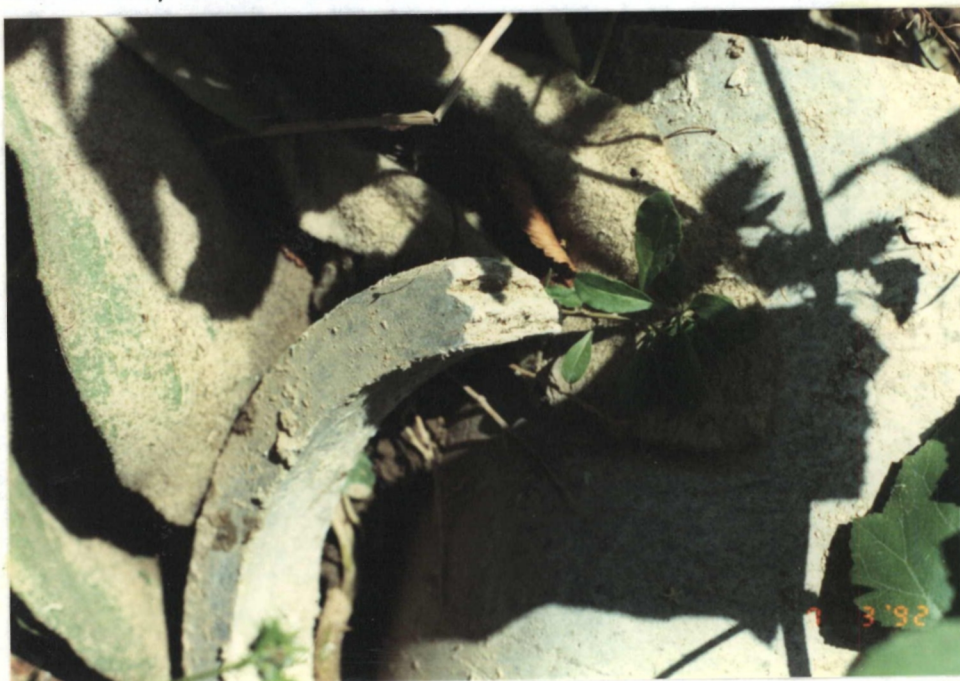
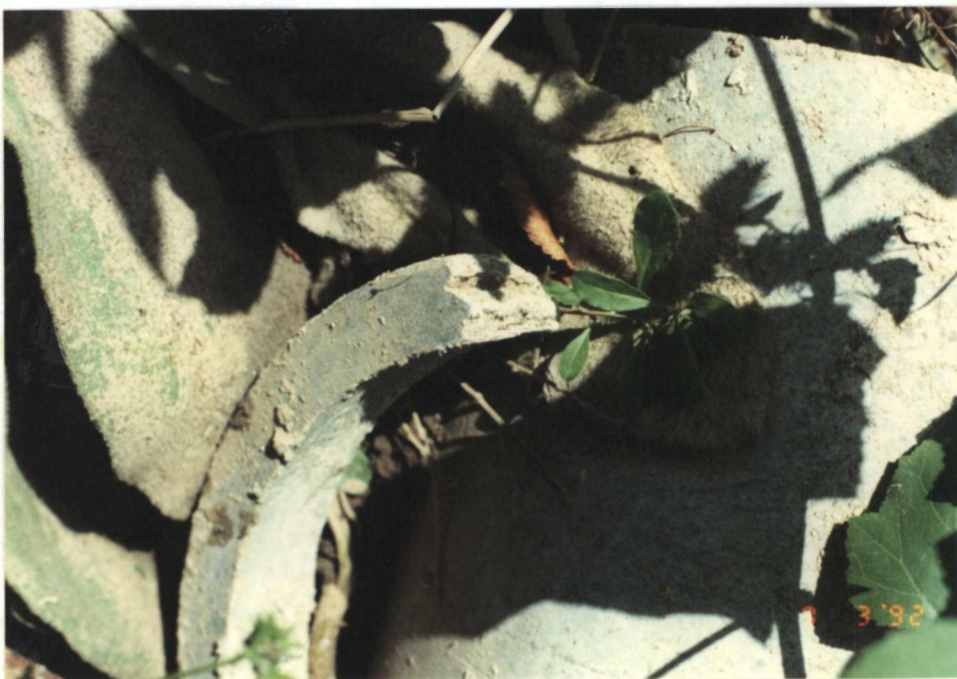
Transite connector rings
showing asbestos fibers

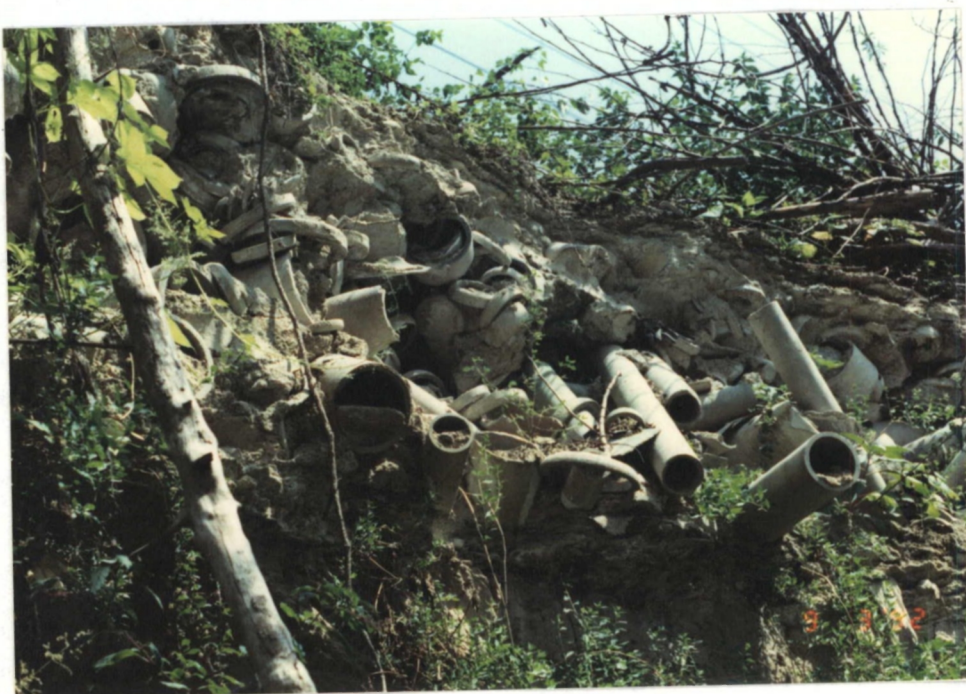
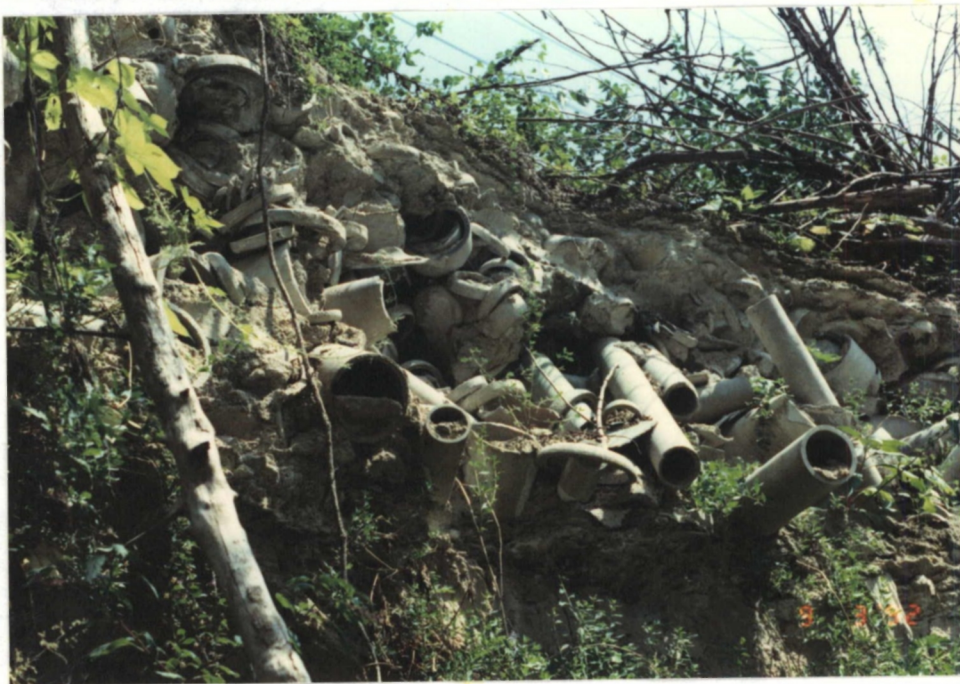
Connector rings, NE bank
